Inspection Date: **15-Nov-2024**

Report Number: **QCR-MC1753**

Manufacturer: MOCO	Brand: MCo	Model Number: MCo Target Display-Kit-1
---------------------------	-------------------	---

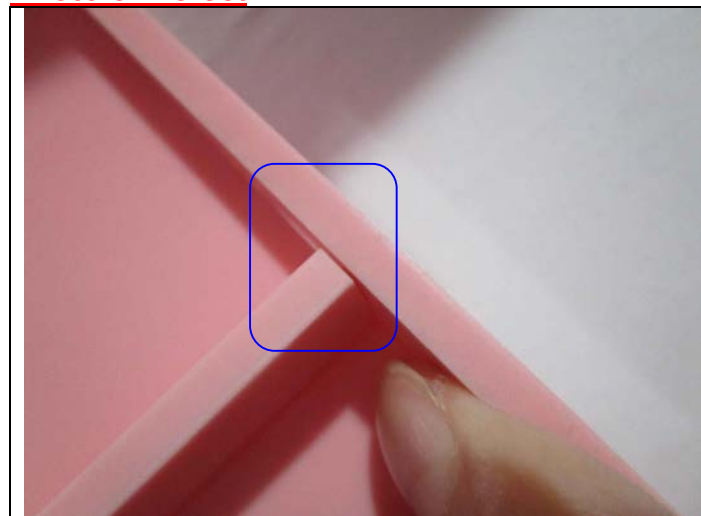
The artwork box panel is loosed (the glue is not firmly attached).

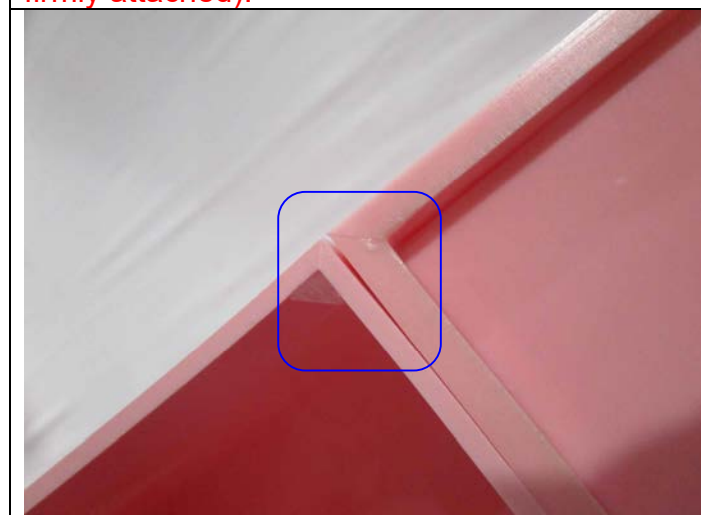
The artwork box panel is loosed (the glue is not firmly attached).

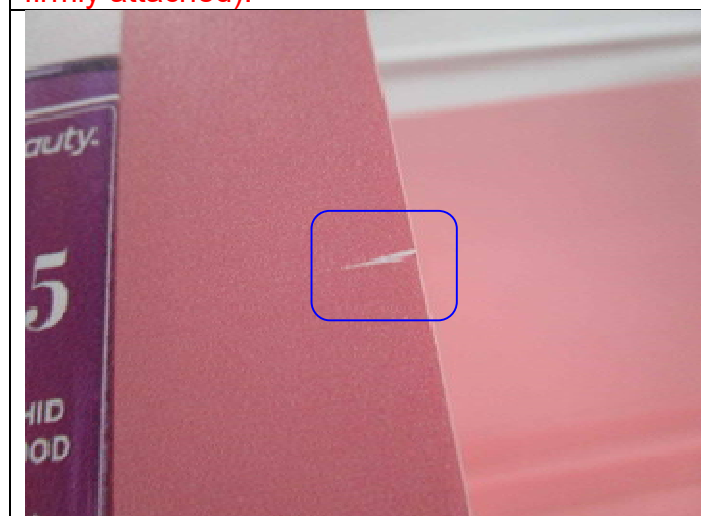
Artwork has scratched

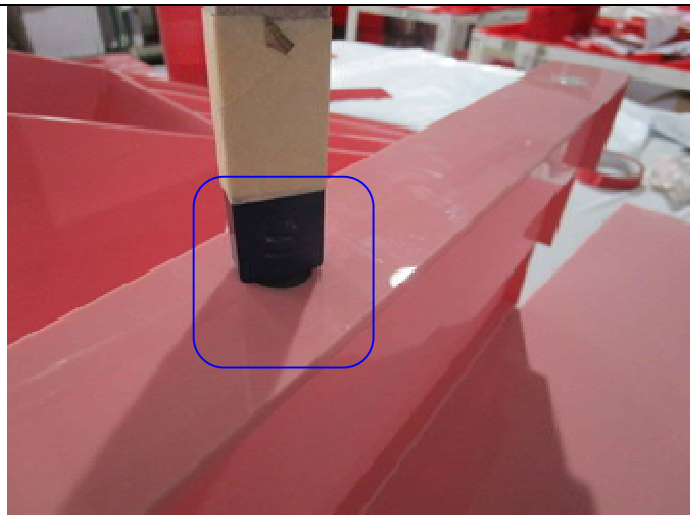
The magnet is not magnetized

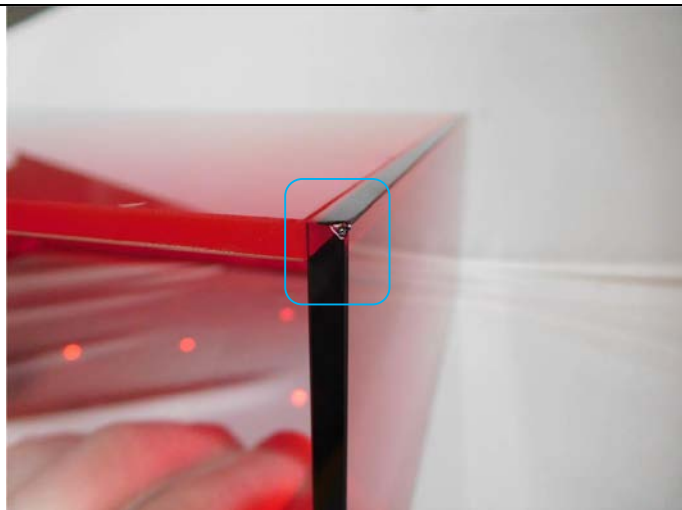
The panel of the window is damaged

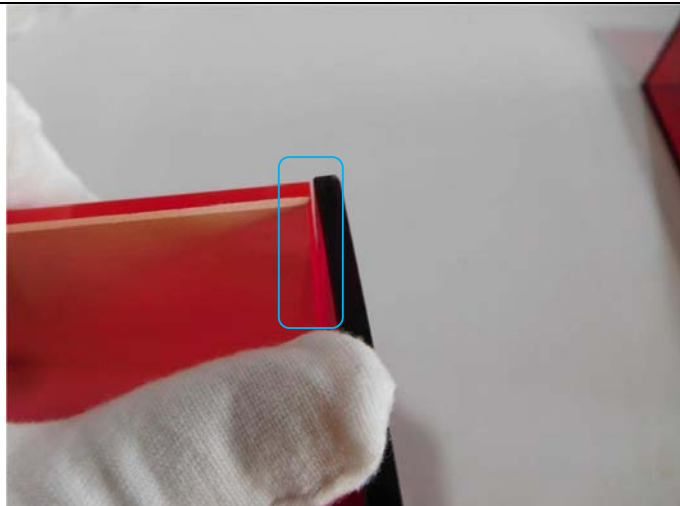
The window is cracked (the glue is not firmly attached).
