Inspection Date: **17-Nov-2024**

Report Number: **QCR-MC1759**

Manufacturer: MOCO	Brand: MCo	Model Number: MCo Target Display -LIPS WEDGES
---------------------------	-------------------	--

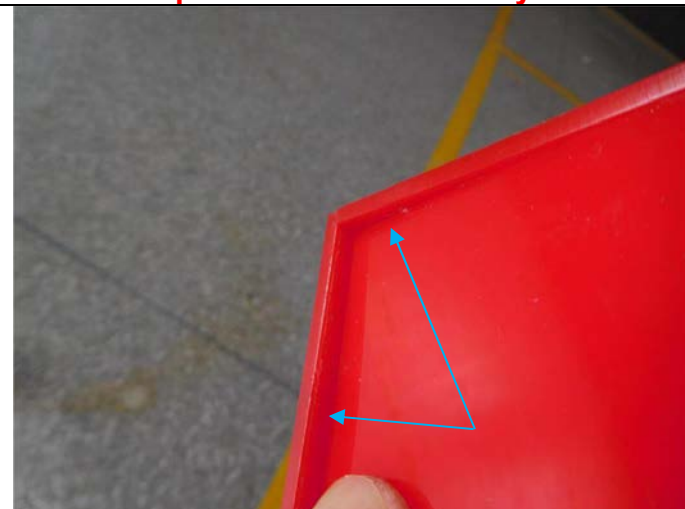
Photo of improvements for the tray loosed

As for the problem that the bottom plate of the tray is not firmly bonded and easy to loose, the factory has made improvements to this problem. This improvement is to add support ribs inside the tray to obtain more bearing area and glue bonding points. Please refer to page 2 for details:

This improvement is to add support ribs inside the tray to obtain more bearing area and glue bonding points.

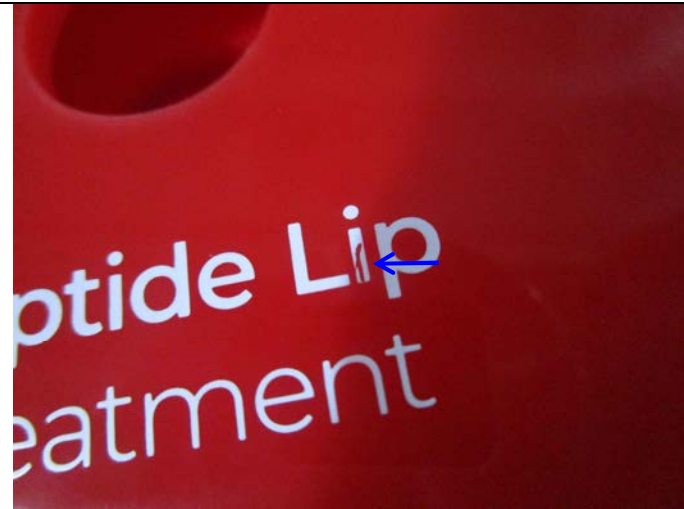
Silk screen scratched

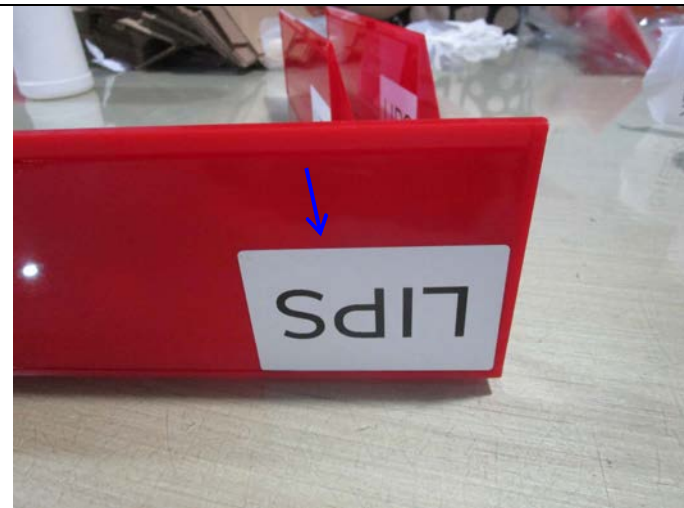
The sticker is upside down

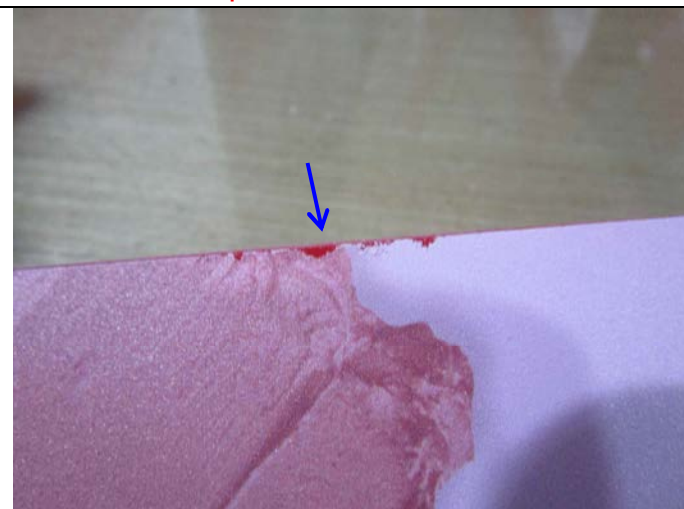
Artwork has damaged
