Report Number: **QCR-MC1757**

| Manufacturer: MOCO | Brand: MCo | Model Number: MCo Target Display -LIPS WEDGES |

I. DOCUMENT CHECK

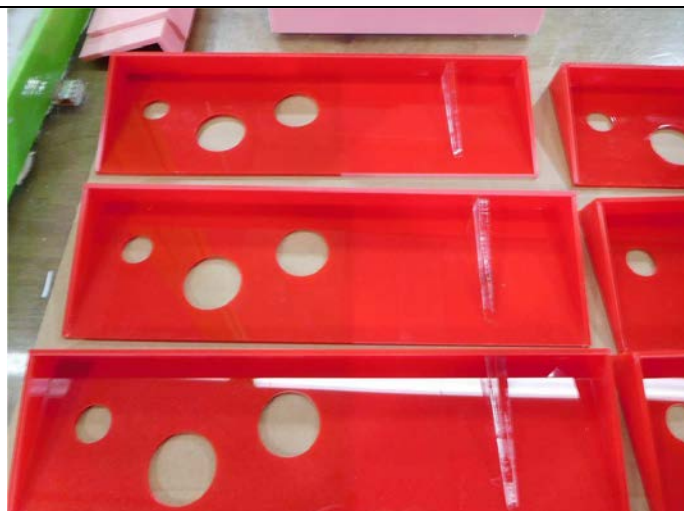
Photo of improvements for the tray loosed

As for the problem that the bottom plate of the tray is not firmly bonded and easy to loose, the factory has made improvements to this problem. This improvement is to add support ribs inside the tray to obtain more bearing area and glue bonding points. Please refer to page 2 for details:

| | Critical | Major | Minor | Analysis |
|---|--|---|---|---|
| REMARKS | As for the problem that the bottom plate of the tray is not firmly bonded and easy to loose, the factory has made improvements to this problem. This improvement is to add support ribs inside the tray to obtain more bearing area and glue bonding points. Please refer to page 2 for details: | | | |

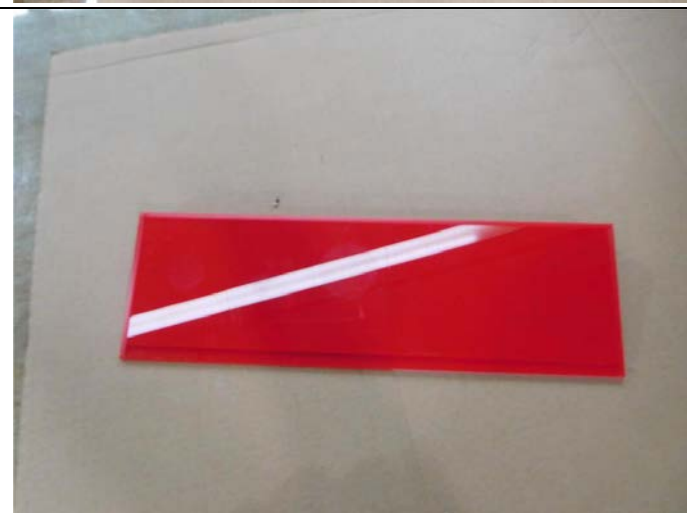
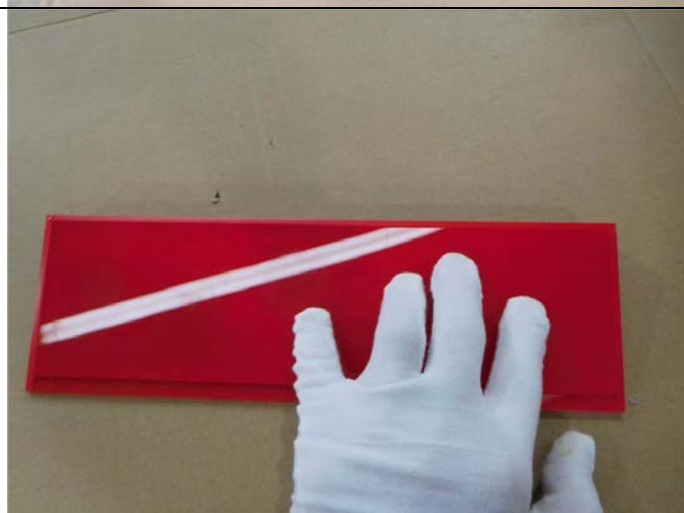
This improvement is to add support ribs inside the tray to obtain more bearing area and glue bonding points.
