Inspection Date: **15-Nov-2024**

Report Number: **QCR-MC1753**

Manufacturer: MOCO	Brand: MCo	Model Number: MCo Target Display-Kit-1
---------------------------	-------------------	---

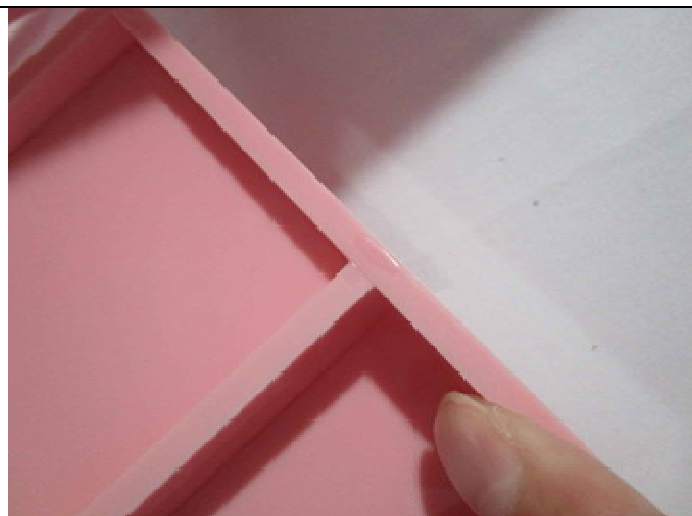
The artwork box panel is loosed (the glue is not firmly attached).

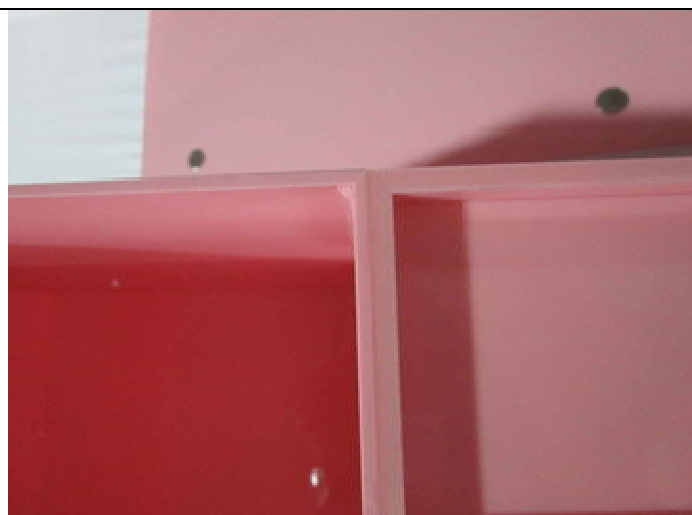
The artwork box panel is loosed (the glue is not firmly attached).

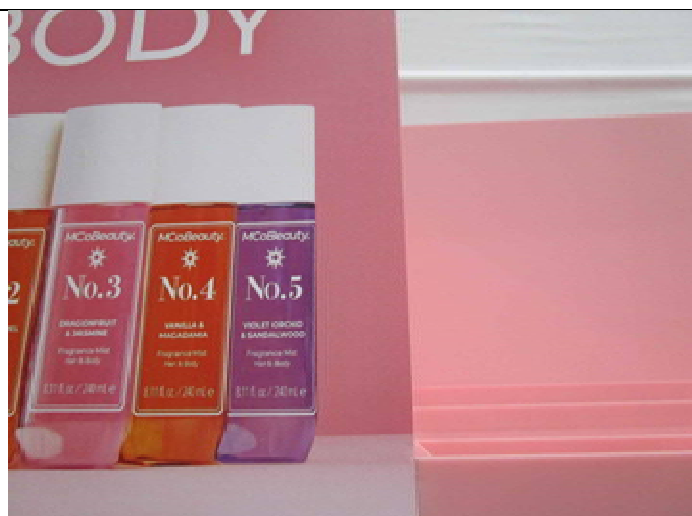
Artwork has scratched

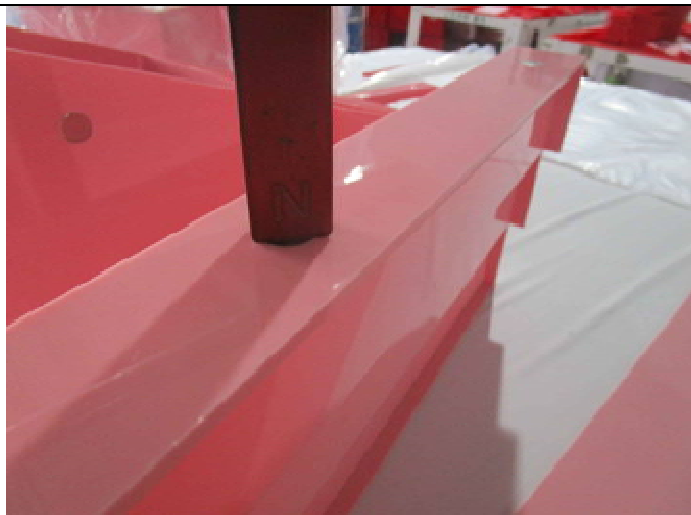
The magnet is not magnetized

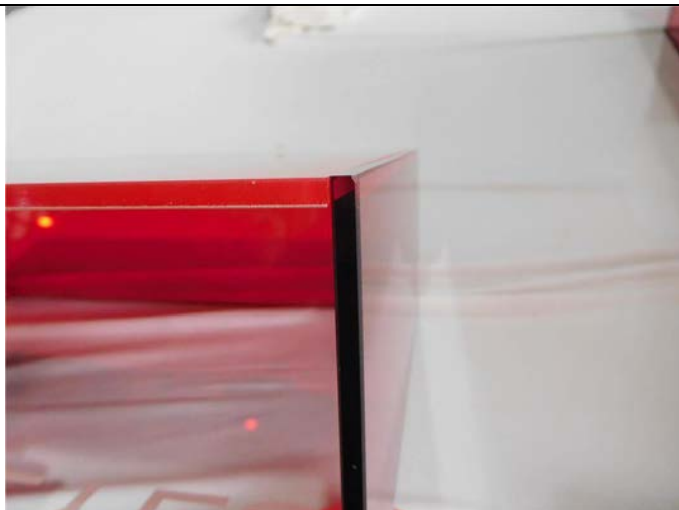
The panel of the window is damaged

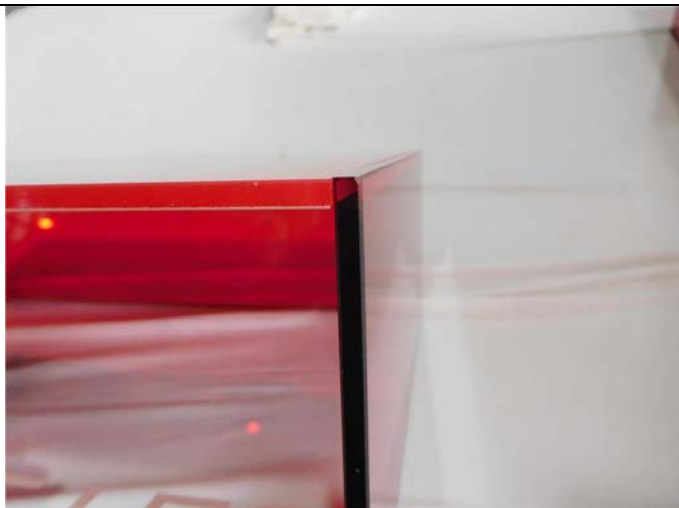
The panel of the window protrudes out of the plane

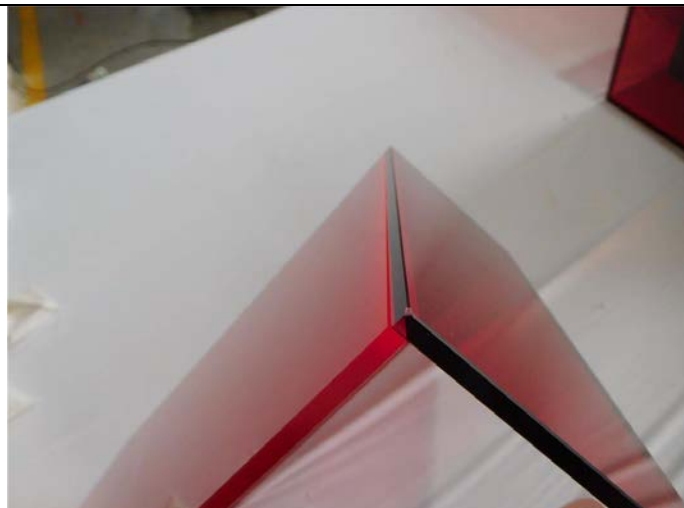
The window has no chamfer

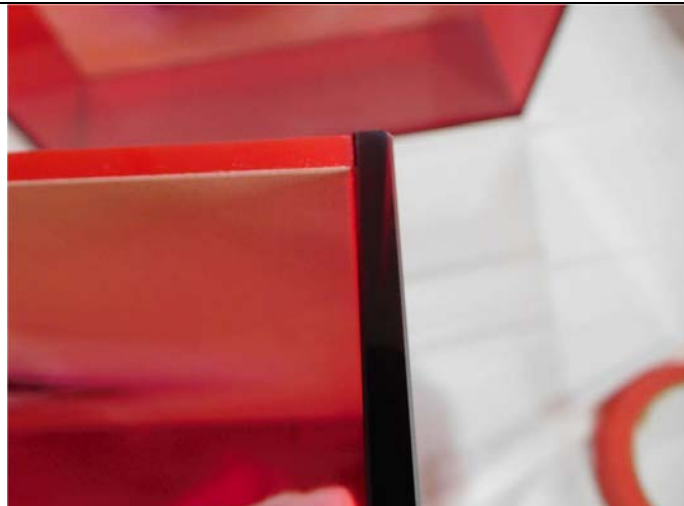
The window is cracked (the glue is not firmly attached).

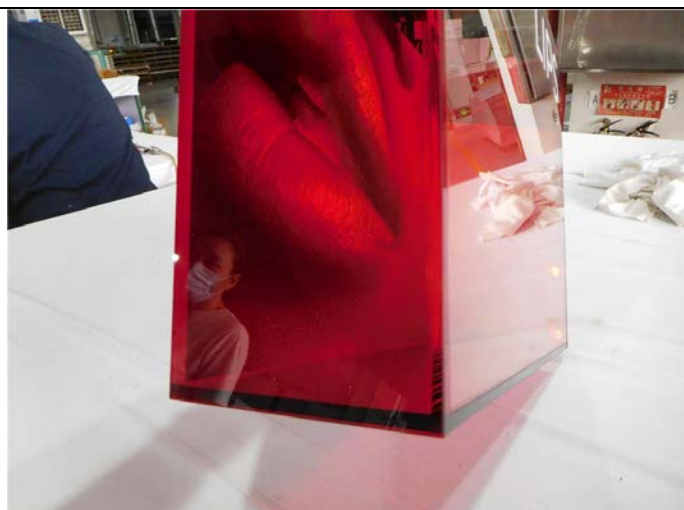
The window has a white border
